ISLAND CREST WAY

SAFETY RECOMMENDATIONS

CITY OF MERCER ISLAND

MARCH 2022

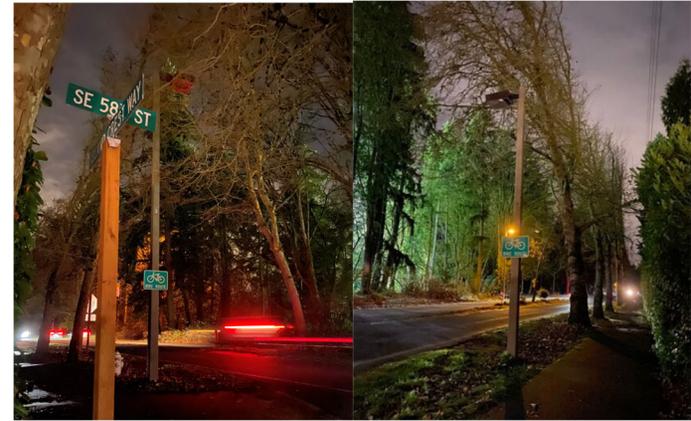
During the study period, there were 15 crashes that occurred during non-daylight conditions. In particular, 21% of crashes reported dark conditions with street lights on, as shown in Figure 8. During the PM peak field visit, the study team observed the street lighting and noticed that two street lights were not functioning on both sides of SE 58th Street entrance on the east side of Island Crest Way, as shown in Figure 9.

FIGURE 9. STREETLIGHTS OUT ON BOTH SIDES OF SE 58TH ST INTERSECTION (12/2/2021).

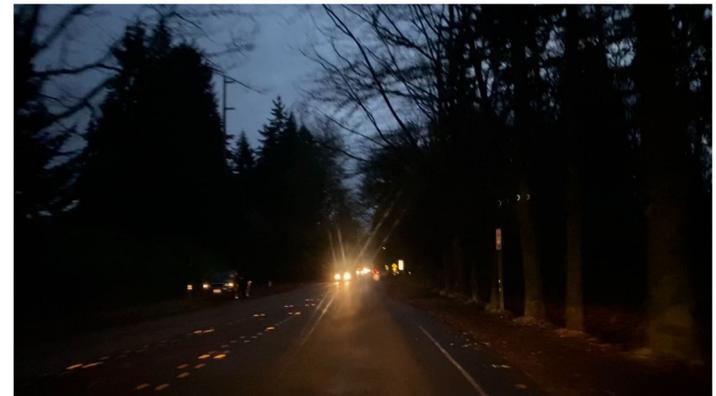
Once the area gets dark, which is around 5 PM during the winter time, the areas without street lights have limited visibility, as shown in Figure 10. Without daylight, it can be difficult to see the edge line striping (which was not exhibiting retroreflectivity during the field review), centerline reflectors, and trees that border the roadway. As a pedestrian on the sidewalk or a cyclist sharing the road, it can be difficult for drivers to see them in the dark along this corridor.

FIGURE 10. ISLAND CREST WAY AT NIGHT.

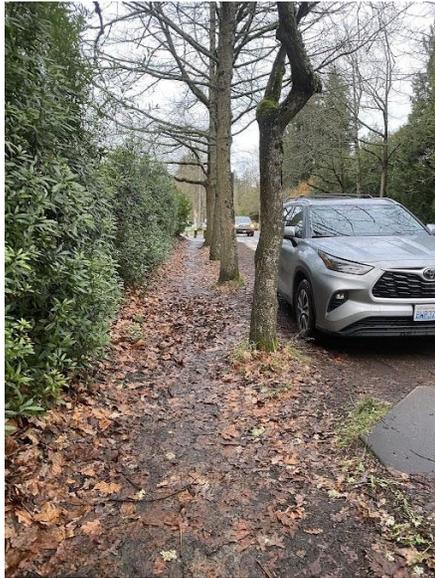
Along the east side of the study corridor, there is a paved, shared use path approximately 6-8 foot wide with a buffered grass shoulder from the road. On the west side of Island Crest Way, there is a soft surface path that is used by pedestrians; however, it meanders and slopes around trees, vegetation, and driveways. The west side informal path is often used by adults who park on the shoulders of Island Crest Way and wait for the students during pick-up times. However, during wet road conditions, the unpaved path becomes uneven and muddy. Photo A on the next page shows the narrow, muddy path, just south of the Elementary School RRFB on the west side. During the afternoon pick-up time, the project team observed several pedestrians walking on the road, against opposing traffic, in order to avoid the muddy trail.

Photo A: Informal path on the west side of Island Crest Way, just south of the Island Park Elementary School (facing northbound).

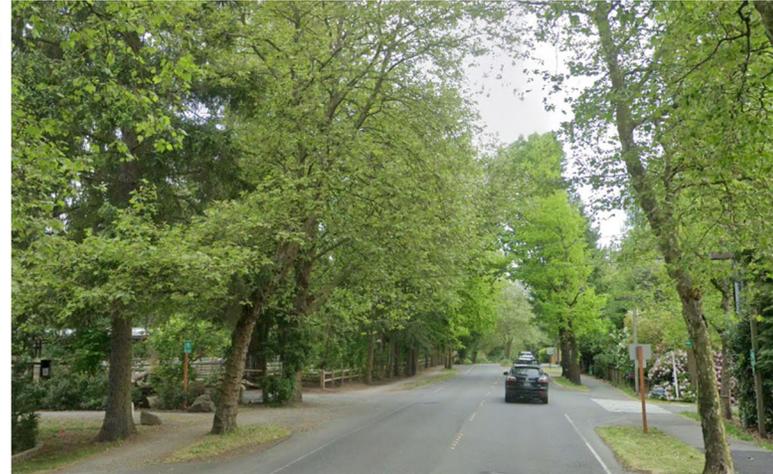
B

Photo B: Bike Route crossing south of SE 62nd Street (facing northbound). Existing street light on the east side. No lighting provided on the west side of Island Crest Way at this crossing.

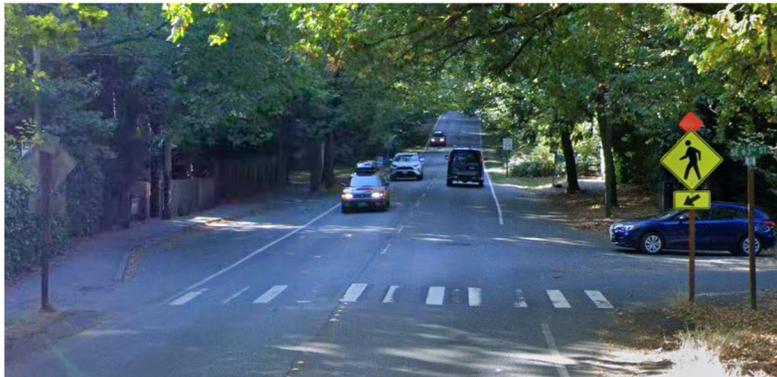
C

Photo C: Marked crossing at SE 63rd Street with signing (facing southbound).

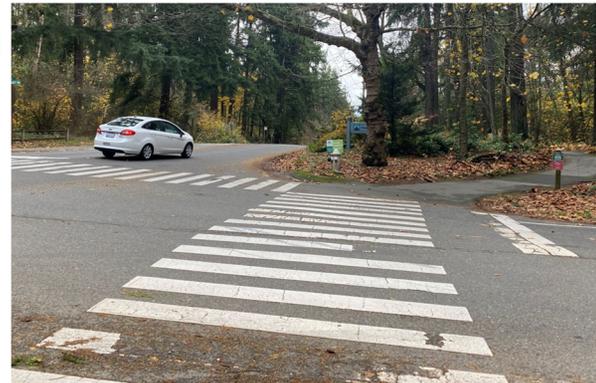
D

Photo D: Marked crossing at SE 68th Street intersection (facing northbound from southeast corner).

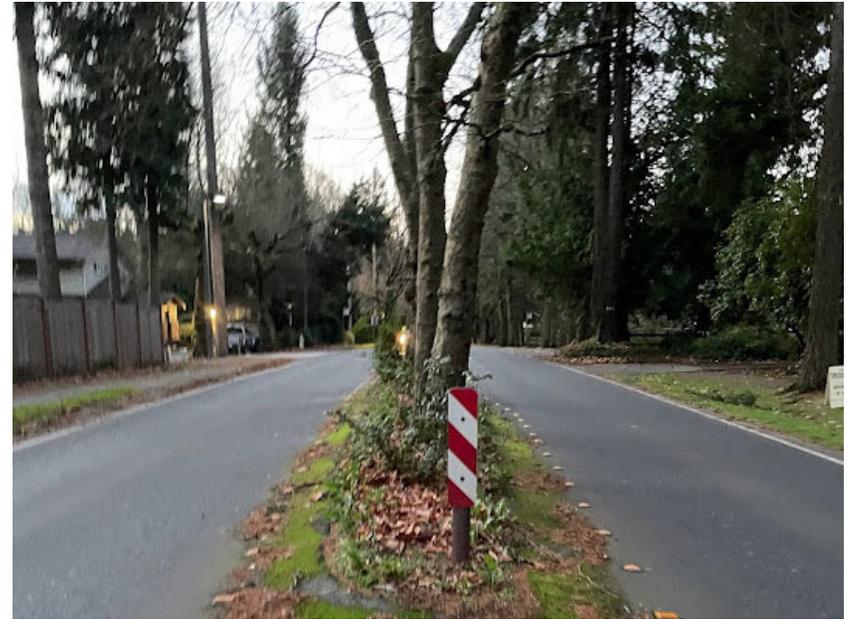
Pavement Marking. In general, pavement marking is worn and needs to be re-marked along the edgeline and at crosswalks. Some centerline marking is only raised pavement markers with no striping underneath. When markers are non-reflective or missing, this causes gaps in delineation.

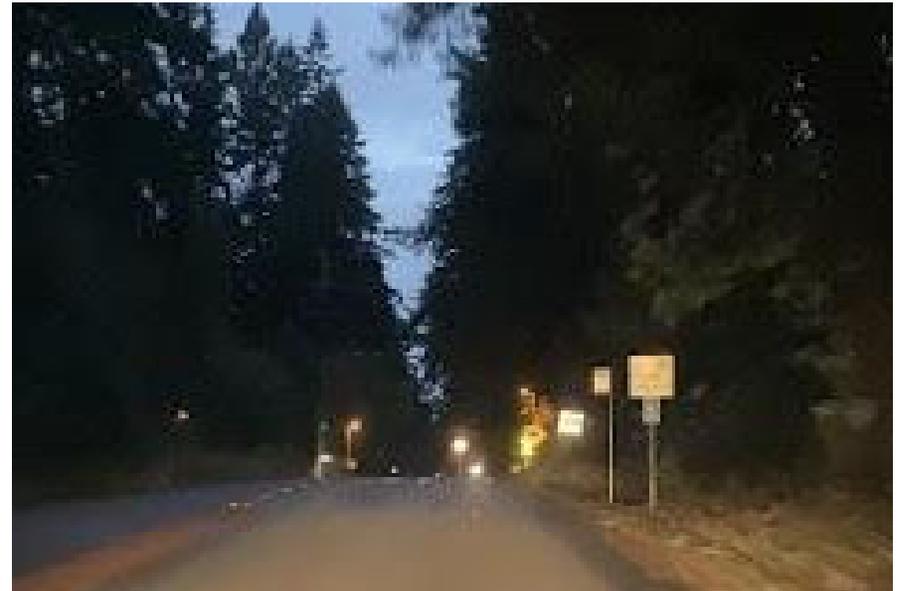
The southbound approach has a vertical grade approaching the intersection, making it difficult for drivers to know there is an intersection approaching. As shown in Figure 15, leading up to the intersection, there are multiple signs on the west side of the road, which are difficult to read as they are installed in close proximity to one another. Due to approach grade, faded edgeline pavement markings, and absence of curbs, drivers may have limited visibility approaching roadside objects.

FIGURE 15: SIGNAGE ON WEST SIDE, APPROACHING SOUTHBOUND OF SE 68TH ST INTERSECTION.
