# **Public Rights-of-Way ADA Curb Ramp and Transit Stop Summary of Findings**

**December 2024**

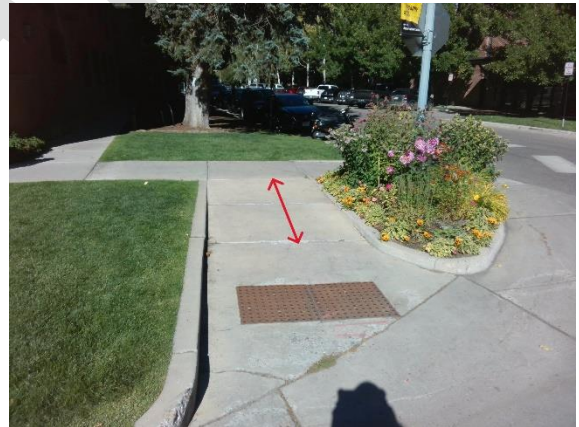
### a. Curb Ramp Run Slope

- 26% of all curb ramps had run slope issues.

\*Maximum Ramp Run Slopes of 8.33% is permitted for a length of fifteen feet per PROWAG.

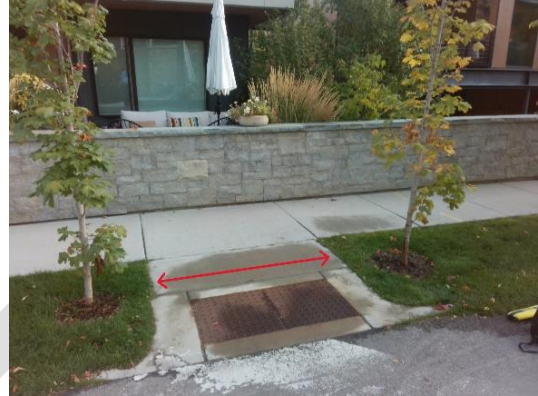
## b. Curb Ramp Cross Slope

- 53% of Curb Ramps met cross slope requirements.
- 47% of Curb Ramps had cross slope issues. Of these, 40% fell into a 2-3% cross slope range, generally considered less severe than higher ranges.

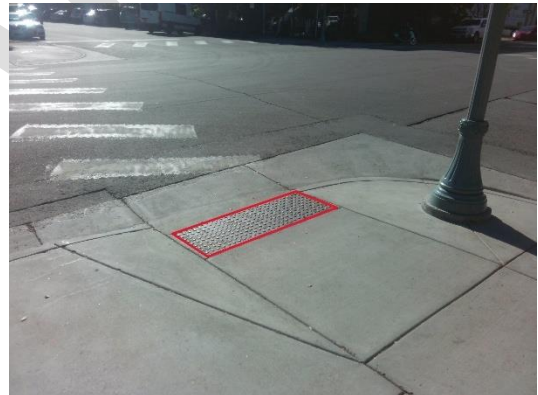
## c. Detectable Warning Surfaces (DWS)

- DWS falling in the Non-Compliant count were most often due to the DWS not extending for the full width of the ramp

\*Of the 238 which failed at an early Initial Pass/Fail scenario, the ramps failed for other non-compliant ramp component reasons, and there is most often some degree of reconstruction necessary. For these ramps, any DWS concern will be addressed when the ramp is corrected for compliance.

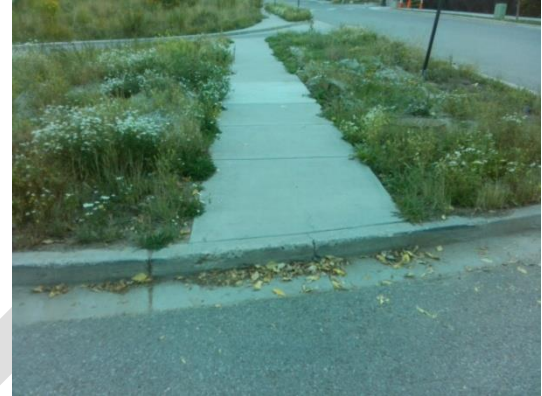
#### d. Missing Curb Ramp

- Missing Curb Ramps are ramps that are not present in locations where they are required.
- T-Intersections can sometimes be the cause of a report of missing curb ramps. These locations most often must be reviewed closely by the City to determine if an alternate approach can be taken to rectify the concern.

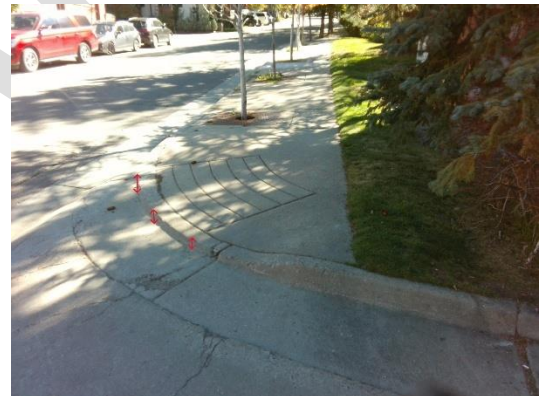
#### e. Curb Ramp Gutter

- 30% of curb ramp gutters are compliant
- Of the 70% of non-compliant gutters, 55% of them have issues with lip height. Grinding down the vertical deviations along these gutters would be a solution.

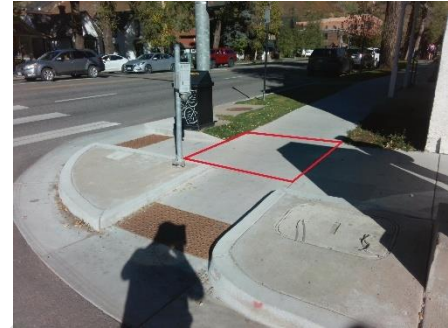
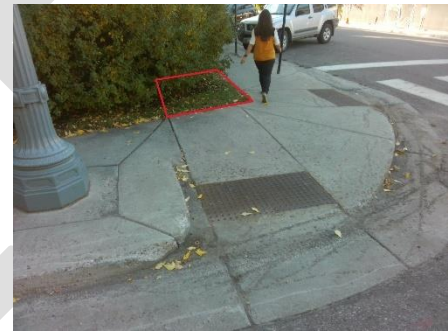
### e. Curb Ramp Landing

- Landings are needed for a change of direction and give access to the pedestrian access route
- Landings are required to be at the top of every curb ramp, often the working area will determine the location of said landing.

\*238 failed initial validation, requiring curb ramp replacement. Landings were not evaluated.

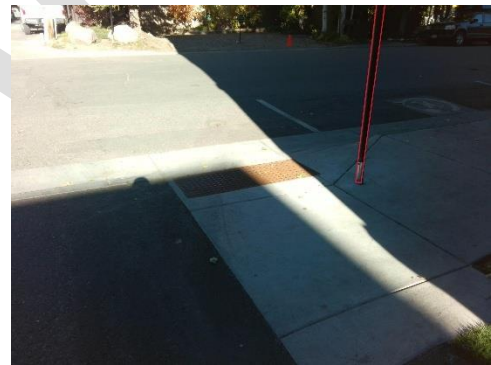
### e. Curb Ramp Obstruction Compliance

\*Anything that restricts the ramp or sidewalk to less than 36" wide.

- Utilities can often interfere with the pedestrian access route.
- Vegetation growth can cause clear width issues

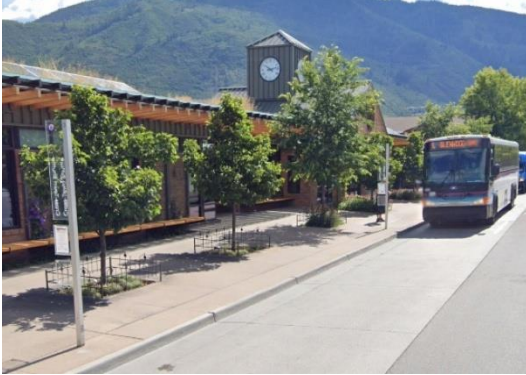
#### a. Transit Stop Access from the pedestrian access route (PAR)

- 96% of the Transit Stops have access to the pedestrian access route.

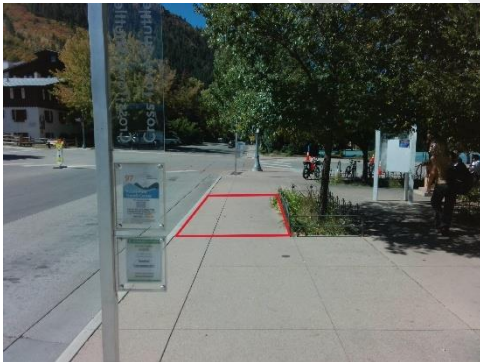
#### b. Boarding Compliance

\*Minimum requirements of 60"x96"

- 33% of the Transit Stops have a compliant boarding area.

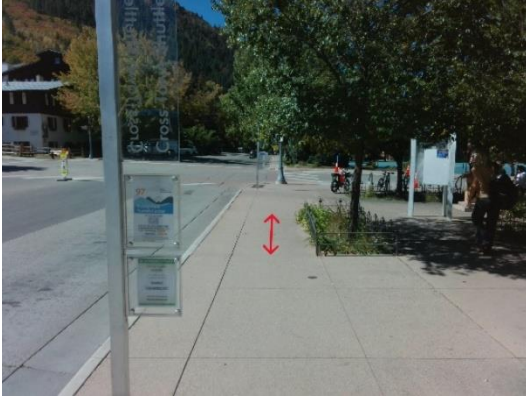
### c. Pedestrian Access Route Slopes to Transit

\*Slopes of the Pedestrian Access Route (PAR) to Transit Stop

- 30% of the cross slopes for the PAR are compliant

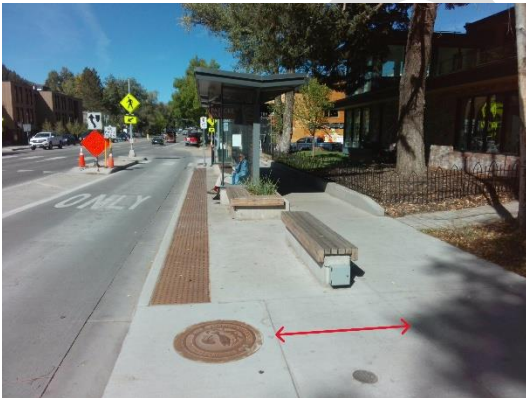
### d. Pedestrian Access Route Slopes to Boarding Area

\*Slopes of the Pedestrian Access Route (PAR) to the Boarding Area.

- 57% of the cross slopes for the PAR are compliant

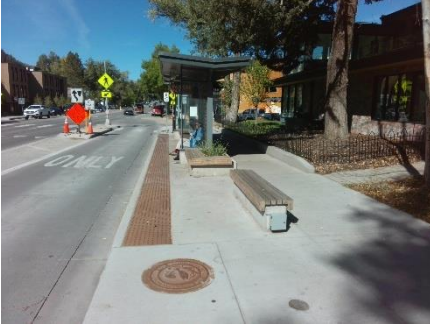
### e. Clear Space Compliance

\*Minimum requirements of 30"x48" of unobstructed space connected to the Pedestrian Access Route when a shelter or bench exists.

- Out of the 30 Transit Stops, 36% have a bench and/or shelter requiring a clear space. Of those Transit Stops that need a clear space, 19% are compliant

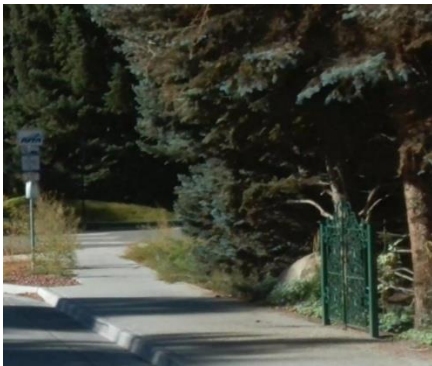
### f. Protruding Object Compliance

- Vegetation can grow over Boarding Area

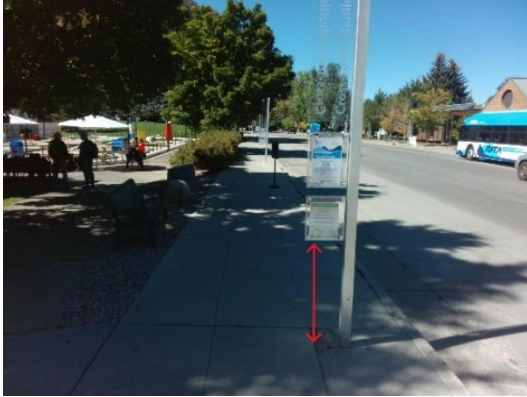
## g. Sign Compliance

- 80% of the Sign Heights are non Compliant.

\* (PROWAG R402.3.1) Where objects are mounted on a single post or pylon and the objects are more than 27 inches (685 mm) and less than 80 inches (2030 mm) above the walking surface, the objects shall not protrude into the *pedestrian circulation path* more than 4 inches (100 mm) measured horizontally from the post or pylon or more than 4 inches (100mm) measured horizontally from the outside edge of the base where the base height is 2 ½ inches (64 mm) minimum.
