# Town of Dedham Facilities Master Plan

Community Engagement

JUNE 15, 2026

ARROWSTREET

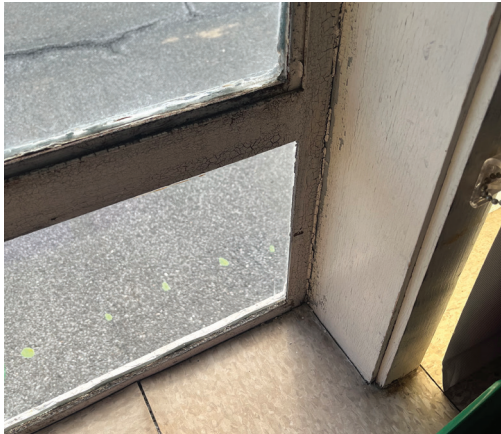
## Windows & Building Envelope

- SIGNIFICANT AT:**
- HIGH SCHOOL
  - GREENLODGE SCHOOL
  - OAKDALE SCHOOL
  - RIVERDALE SCHOOL
  - DPW

- Including windows, roofs, and exterior masonry
- Original single-pane windows across multiple locations.
  - Energy inefficient, drafty, and at end of useful life.
  - Multiple building have masonry and roof deteriorating.
  - Leaks accelerate deterioration of interior condition
  - Replacement yields comfort improvements and significant heating cost savings, also eligible for energy rebates.

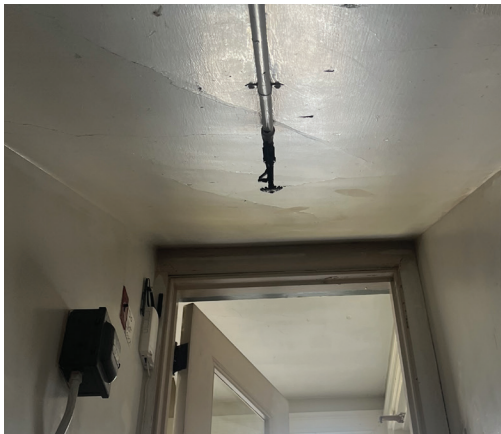
## Fire & Life Safety Code Gaps

- SIGNIFICANT AT:**
- EAST DEDHAM FIRE STATION
  - HIGH SCHOOL
  - OAKDALE SCHOOL
  - RIVERDALE SCHOOL
  - GREENLODGE SCHOOL
  - PARKS & RECREATION
  - ENDICOTT ESTATE

- Fire and life safety code govern systems to assist occupants during an emergency.
- Existing conditions generally can remain, any new or renovated features must comply with current standards, certain triggers require full upgrades
  - Older schools lack sprinkler and fire alarm systems required in new or substantially renovated buildings

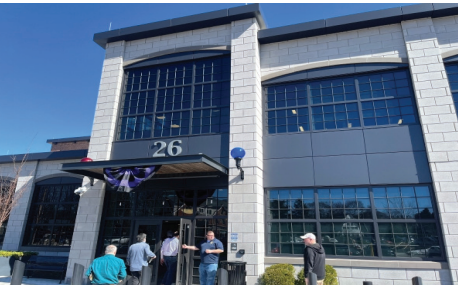
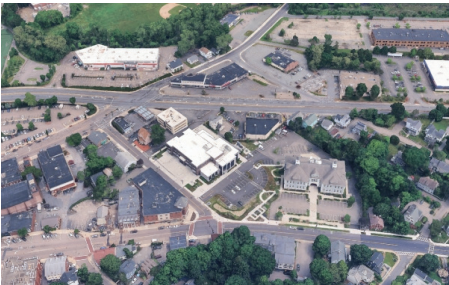
BUILDING PHOTO

| FACILITY CONDITION INDEX (FCI) | | | EDUCATIONAL ADEQUACY INDEX (EAI) | | |
|---|---|---|---|---|---|
| OVERALL FCI: | 1.05 | Excellent | OVERALL EAI: | - | N/A |

- Building is in excellent condition, continue to maintain to protect new asset
- Implement climate roadmap when HVAC nears end-of-life (~2045)

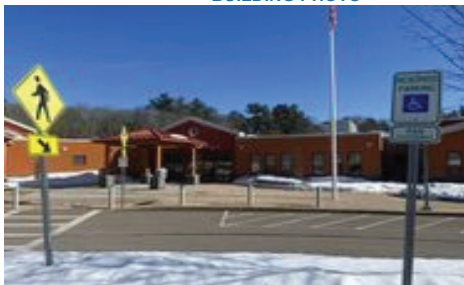
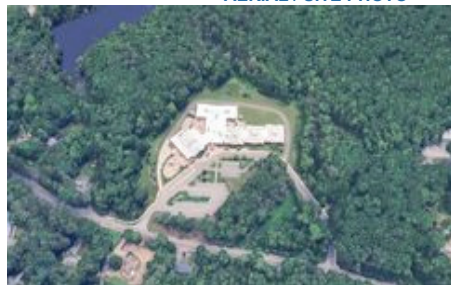
BUILDING PHOTO

| FACILITY CONDITION INDEX (FCI) | | | EDUCATIONAL ADEQUACY INDEX (EAI) | | |
|---|---|---|---|---|---|
| OVERALL FCI: | 1.19 | Excellent | OVERALL EAI: | 1.27 | Excellent |

| Building Findings | |
|---|---|
| Minor | Minor code deficiencies to plumbing, and HVAC systems |

| Consultant’s Initial Consideration | |
|---|--|
| <ul style="list-style-type: none"><li>Building is in excellent condition, continue to maintain to protect new asset</li><li>Implement climate roadmap when HVAC nears end-of-life (~2045)</li></ul> | |

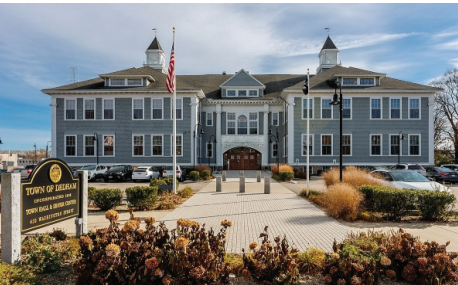
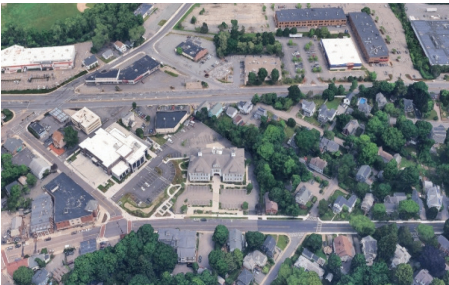
BUILDING PHOTO

| FACILITY CONDITION INDEX (FCI) | | | EDUCATIONAL ADEQUACY INDEX (EAI) | | |
|---|---|---|---|---|---|
| OVERALL FCI: | 1.26 | Excellent | OVERALL EAI: | - | N/A |

Minor code deficiencies to plumbing, and electrical systems

- Building is in excellent condition, continue to maintain to protect new asset, although historic buildings have higher maintenance costs.
- Continue to evaluate town department needs over time as operations evolve.

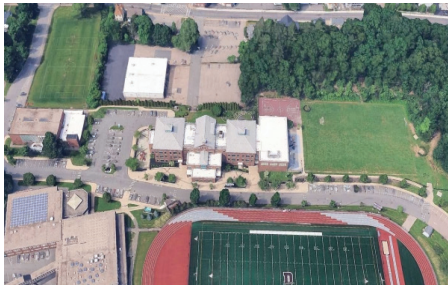
AERIAL / SITE PHOTO

| FACILITY CONDITION INDEX (FCI) | | | |
|---|---|---|--|
| OVERALL FCI: | 1.41 | Good | |

Minor site repairs - sidewalks, entry pavers, consider scheduled court sealing

Avery Elementary School is in good condition, but near term planning for major systems replacements should begin to prevent deterioration of the building.

Plan to replace HVAC system nearing the end of useful life

Plan to replace roof system nearing the end of useful life

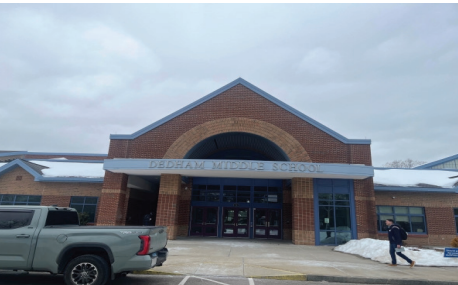
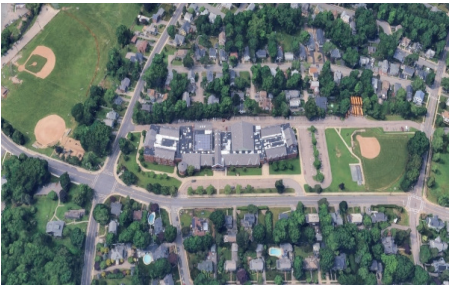
BUILDING PHOTO

| FACILITY CONDITION INDEX (FCI) | | | EDUCATIONAL ADEQUACY INDEX (EAI) | | |
|---|---|---|---|---|---|
| OVERALL FCI: | 1.61 | Good | OVERALL EAI: | 1.51 | Good |

Roof has active leaks and requires replacement

Repair exterior features which have deteriorated - sidewalks, stairs, loading dock

Minor code deficiencies to electrical systems, and life safety

Plan to replace HVAC system nearing the end of useful life

- Dedham Middle School is in good condition, but has immediate replacement needs and near term planning for major systems replacements to prevent deterioration of the building.

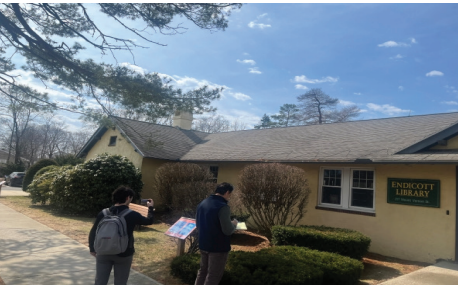
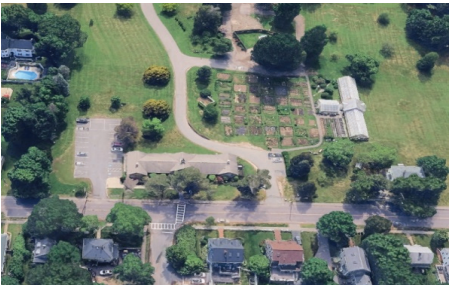
BUILDING PHOTO

| FACILITY CONDITION INDEX (FCI) | | | EDUCATIONAL ADEQUACY INDEX (EAI) | | |
|---|---|---|---|---|---|
| OVERALL FCI: | 2.11 | Fair | OVERALL EAI: | - | N/A |

Moderate code deficiencies to accessibility, electrical systems, and life safety

Plan to replace HVAC system beyond the end of useful life, electrical service upgrade would be required

- Continue maintenance and plan for end-of -life replacements, site issues should be remediated
- Study program sufficiency, space is limited

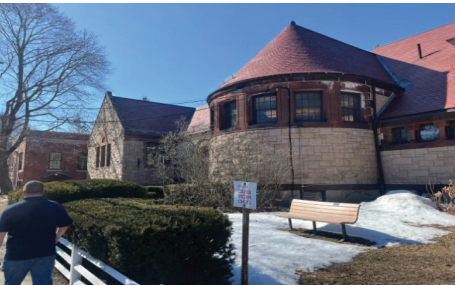
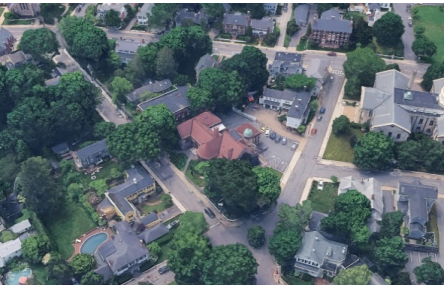
BUILDING PHOTO

| FACILITY CONDITION INDEX (FCI) | | | EDUCATIONAL ADEQUACY INDEX (EAI) | | |
|---|---|---|---|---|---|
| OVERALL FCI: | 2.55 | Poor | OVERALL EAI: | - | N/A |

| High | Replace electrical system for code compliance and service increase |
| Medium | Moderate code deficiencies to accessibility, electrical systems, and life safety |

| Planning | Plan to replace HVAC system beyond the end of useful life |

### SIGNIFICANT REPAIRS REQUIRED - MAINTAIN BUILDING

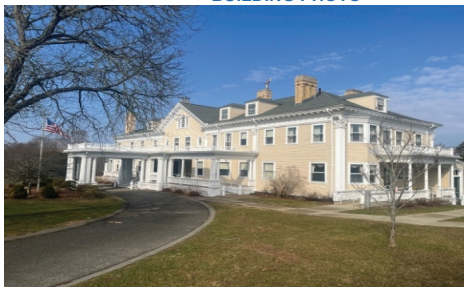
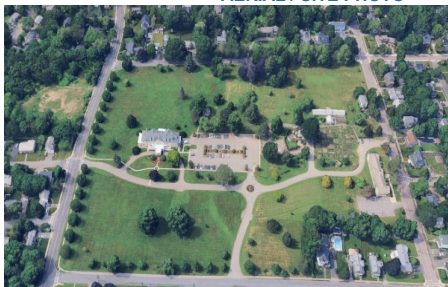
BUILDING PHOTO

| FACILITY CONDITION INDEX (FCI) | | | | EDUCATIONAL ADEQUACY INDEX (EAI) | | | | |
|---|--|---|---|---|---|---|---|---|
| OVERALL FCI: | | 2.62 | Poor | OVERALL EAI: | | - | N/A | |

| Building Findings | |
|---|---|
| Medium | Moderate code deficiencies to accessibility, electrical systems, and life safety |

| Building Findings | |
|---|---|
| Planning | Plan to replace HVAC and Electrical systems nearing the end of useful life |
| <ul style="list-style-type: none"><li>Protect revenue generating asset and prioritize life-safety code related repairs</li><li>Plan capitol investment for HVAC and electrical systems at end of life</li></ul> | |

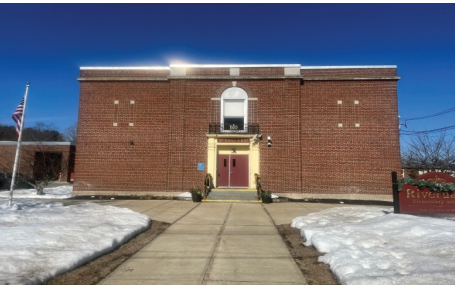
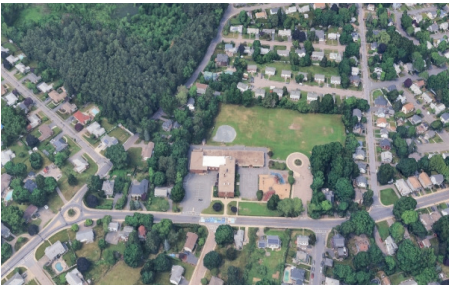
BUILDING PHOTO

OVERALL FCI: **2.77** **Poor**

### REPLACEMENT RECOMMENDED

- Cost to renovate building likely similar to replacement given scope and would not address educational space deficiencies
- Study potential reuse for building and site

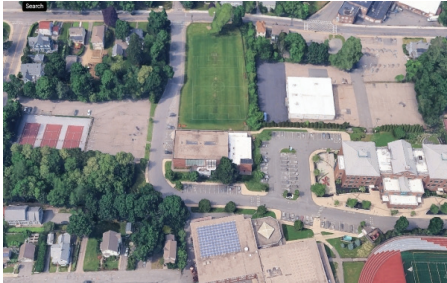
AERIAL / SITE PHOTO

| FACILITY CONDITION INDEX (FCI) | | | EDUCATIONAL ADEQUACY INDEX (EAI) | | |
|---|---|---|---|---|---|
| OVERALL FCI: | 2.81 | Poor | OVERALL EAI: | - | N/A |

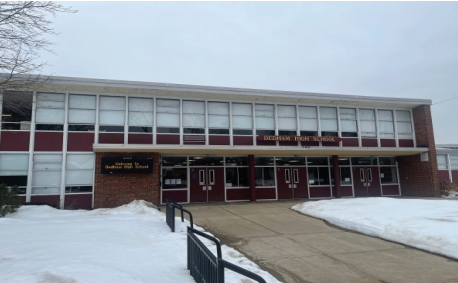
BUILDING PHOTO

| FACILITY CONDITION INDEX (FCI) | | | EDUCATIONAL ADEQUACY INDEX (EAI) | | |
|---|---|---|---|---|---|
| OVERALL FCI: | 2.85 | Poor | OVERALL EAI: | 2.43 | Poor |

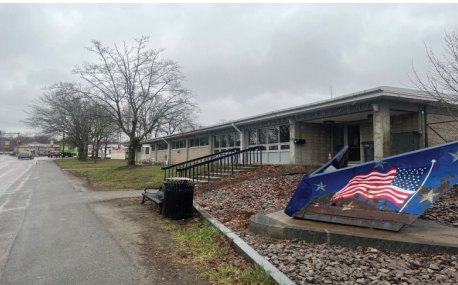
BUILDING PHOTO

| FACILITY CONDITION INDEX (FCI) | | | | EDUCATIONAL ADEQUACY INDEX (EAI) | | | |
|---|---|---|---|---|---|---|--|
| OVERALL FCI: | 2.88 | Poor | | OVERALL EAI: | - | N/A | |

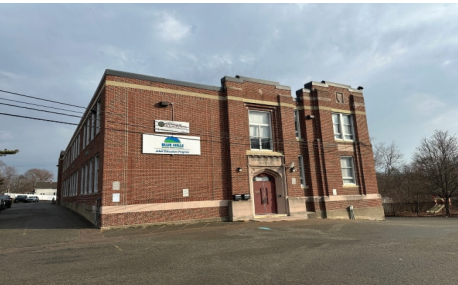
BUILDING PHOTO

| FACILITY CONDITION INDEX (FCI) | | | EDUCATIONAL ADEQUACY INDEX (EAI) | | |
|---|---|---|---|---|---|
| OVERALL FCI: | 2.96 | Poor | OVERALL EAI: | n/a | N/A |

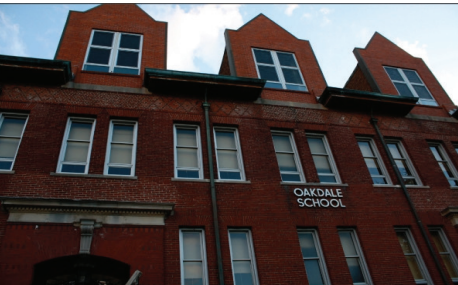
BUILDING PHOTO

| FACILITY CONDITION INDEX (FCI) | | | | EDUCATIONAL ADEQUACY INDEX (EAI) | | | |
|---|---|---|---|---|---|---|--|
| OVERALL FCI: | 3.01 | Poor | | OVERALL EAI: | 3.01 | Poor | |

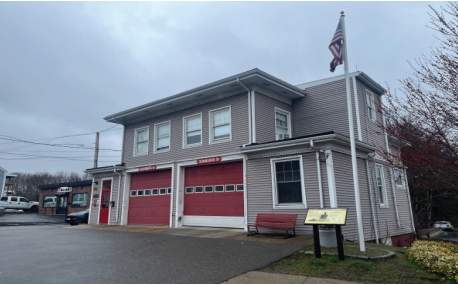
BUILDING PHOTO

| FACILITY CONDITION INDEX (FCI) | | | EDUCATIONAL ADEQUACY INDEX (EAI) | | |
|---|---|---|---|---|---|
| OVERALL FCI: | 3.23 | Critical | OVERALL EAI: | - | N/A |

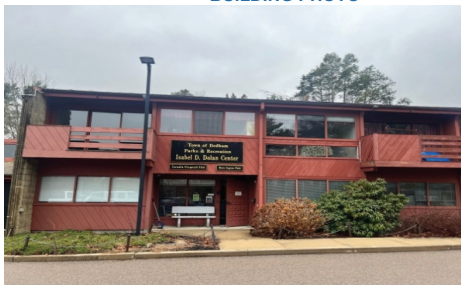
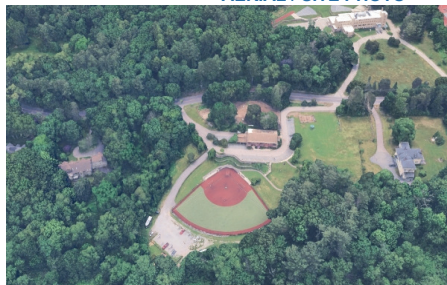
| TOWN OF DEDHAM FACILITIES MASTER PLAN | | BUILDING SUMMARY | |
|---|---|---|---|
| BUILDING PHOTO | | AERIAL / SITE PHOTO | |

| TOWN OF DEDHAM FACILITIES MASTER PLAN | | BUILDING SUMMARY | |
|---|---|---|---|
| OVERALL FCI: | 3.48 Critical | OVERALL EAI: | - N/A |
