ISLAND CREST WAY

SAFETY RECOMMENDATIONS

CITY OF MERCER ISLAND

MARCH 2022

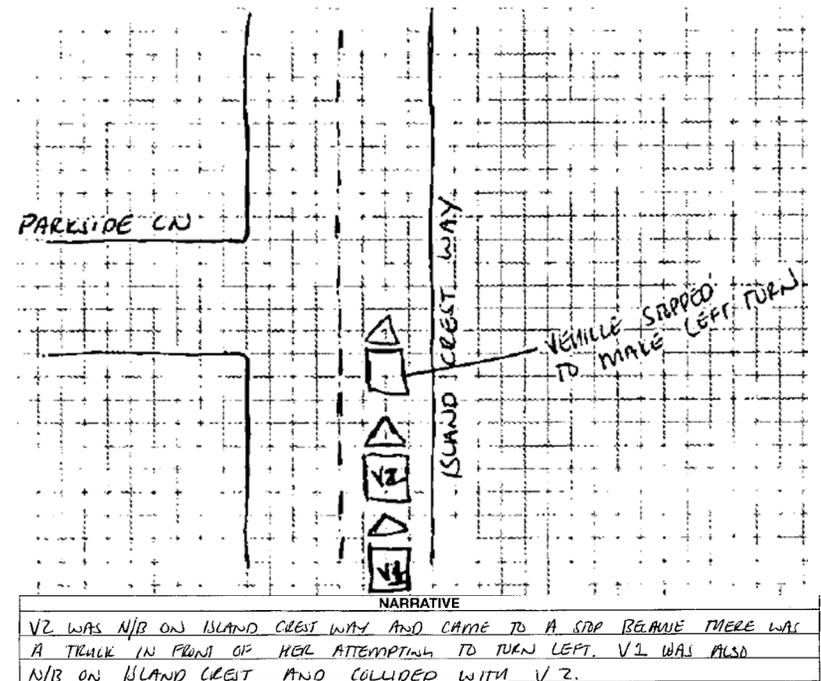
FIGURE 7. EXAMPLE DIAGRAM AND NARRATIVE FROM COLLISION REPORT

- Vehicle stopped for crossing pedestrians
 - SE 63rd Street (Southbound vehicle)
 - Elementary School Pedestrian Crossing
- SE 68th Street: Two primary collision types.

- Most vehicle-vehicle collisions involved a southbound vehicle that did not stop at the Stop sign.
 - Pedestrian-related collisions involved an eastbound left turning vehicle.

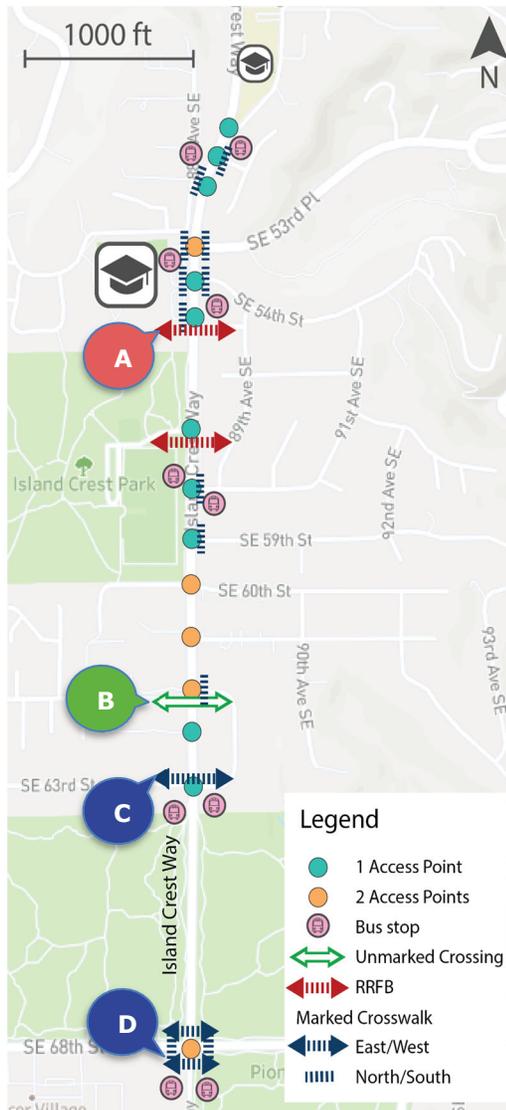
During the study period, three pedestrian-involved and two bicyclist-involved collisions were recorded along the study corridor. Of these five collisions, one resulted in a possible injury, three in a minor injury, and one was a serious injury crash at the SE 63rd Street crosswalk in dark conditions.

The map on the left presents an inventory of access points, transit bus stops, marked crosswalks, and Rectangular Rapid Flashing Beacon (RRFB) locations along the study corridor. The bus stop locations are served by route Metro Transit Route 204 with a bus frequency of 30 minutes. Route 204 is operational Monday - Friday from 5:50 AM to 6:29 PM and Saturday 9:00 AM to 6:01 PM.⁵ There is one RRFB located at the southeast corner of the elementary school and approximately 700 feet south, there is another RRFB located at Island Crest Park. Both RRFB locations have a pedestrian warning sign on one side, facing the oncoming traffic, and are well lit.

Along the east side of the study corridor, there is a paved, shared use path approximately 6-8 foot wide with a buffered grass shoulder from the road. On the west side of Island Crest Way, there is a soft surface path that is used by pedestrians; however, it meanders and slopes around trees, vegetation, and driveways. The west side informal path is often used by adults who park on the shoulders of Island Crest Way and wait for the students during pick-up times. However, during wet road conditions, the unpaved path becomes uneven and muddy. Photo A on the next page shows the narrow, muddy path, just south of the Elementary School RRFB on the west side. During the afternoon pick-up time, the project team observed several pedestrians walking on the road, against opposing traffic, in order to avoid the muddy trail.

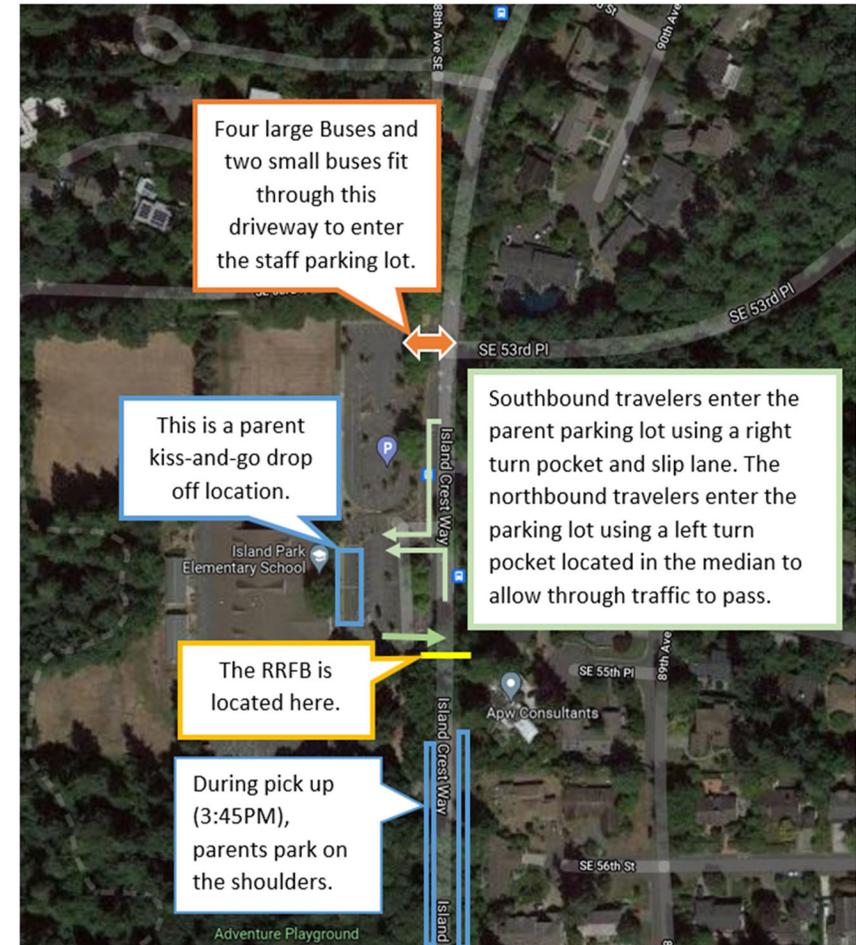
FIGURE 11. ISLAND PARK ELEMENTARY SCHOOL PARKING LOT OPERATIONS.

For the PM peak, the typical school day ends at 3:45 PM. Parents begin waiting in the parking lot at approximately 3:30 PM and the parking lot generally becomes full by 3:40 PM. Other parents park on the unpaved shoulders along Island Crest Way south of the school. The parent parking lot generally clears within 10 minutes of student release. With the help of a flagger, school buses leave the separate parking lot at 3:55 PM at the intersection of SE 53rd Street.

One of the main crossings for the school is the RRFB controlled crosswalk located on the south end of Island Park Elementary School. This crossing is heavily used for students and faculty during the school drop-off and pick-up times and is assisted by a flagger.

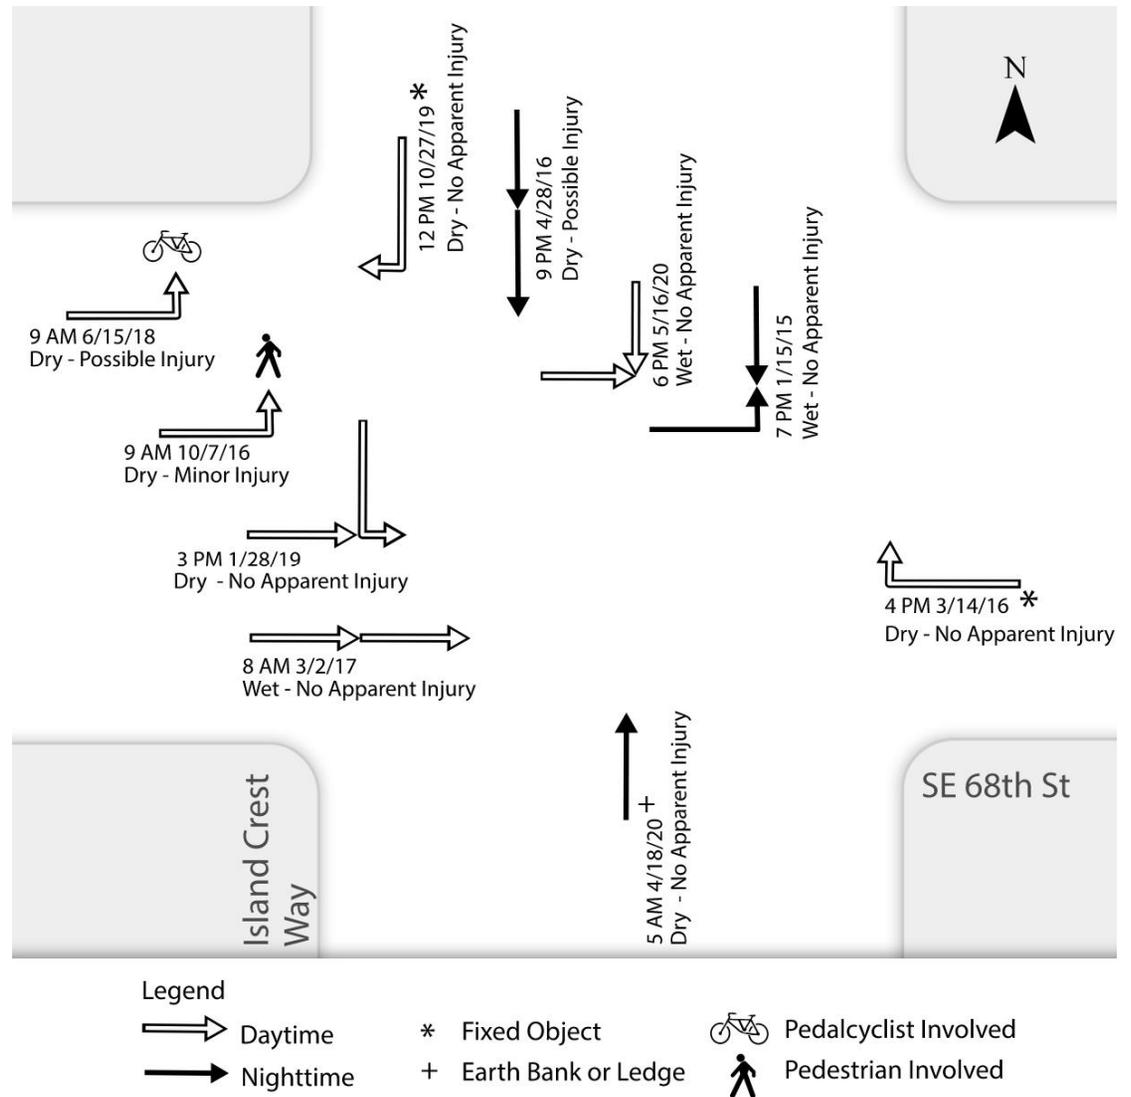
FIGURE 14: CRASH DIAGRAM FOR SE 68TH ST AND ISLAND CREST WAY INTERSECTION (2015-2020).

The crash diagram shown in Figure 14 illustrates the vehicle movements, severity, date, and time of all the crashes that occurred during the study period. There have been two pedestrian and bicycle crashes that involved an eastbound left-turning vehicle. Based on the pedestrian counts collected in 2018, pedestrian activity is present on all four legs, with the highest amount of pedestrian traffic crossing the north leg of the intersection. Also, the study team observed multiple runners during the PM peak field visit in December 2021 at this intersection.

The project team conducted multiple site visits to the SE 68th St intersection. During the afternoon field visit, sunset began around 5:00 PM and the areas without streetlights have limited visibility. Although at the intersection there is sufficient lighting to illuminate the intersection, it is very dark leading up to the intersection for all approaches.
